Shinfield C of E Junior School in Reading was suffering from a seriously failing roof and there was a lot of water ingress from the timber felt roof. IKO PLC were asked to carry out a survey of all the roofs on the site.

**System:** Built-up Felt Roofing

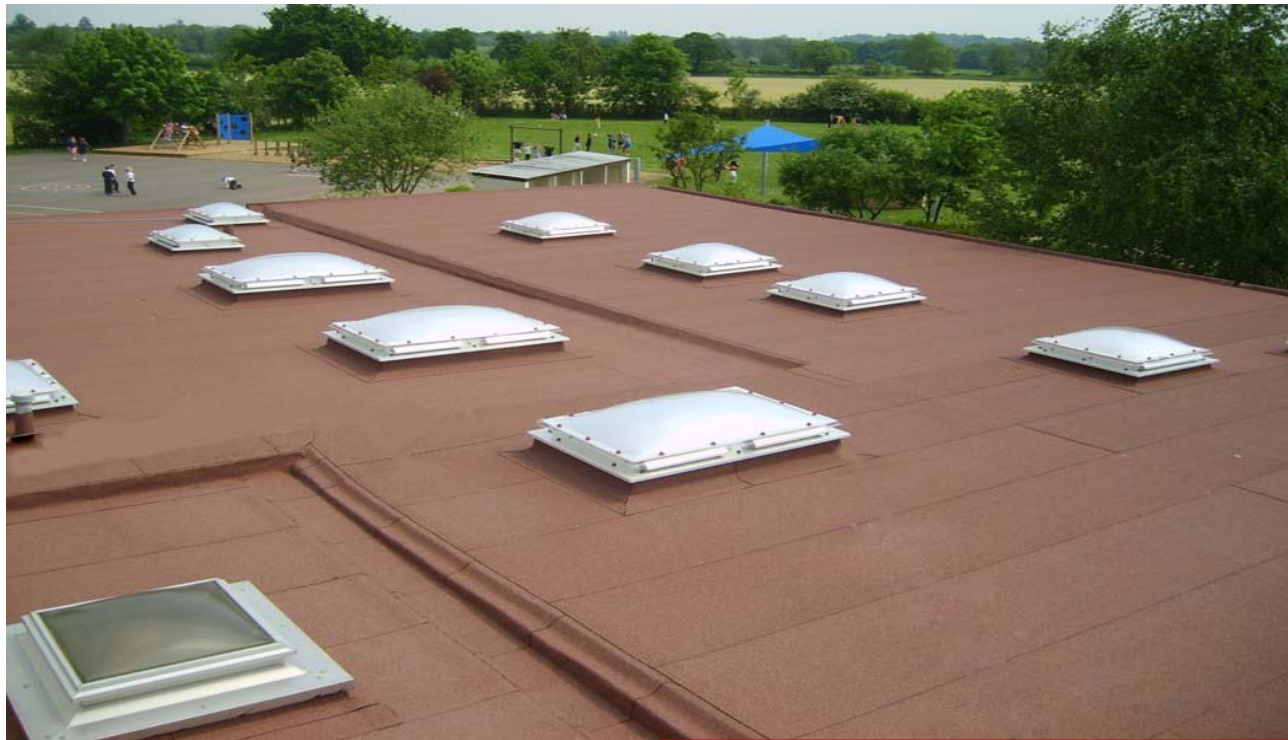
IKO provided the school with a full survey report highlighting a number of problems with the roof. A follow-on Thermographic survey was scheduled which revealed that large areas of insulation were saturated. IKO's suggestion was to completely remove and replace the existing roof, then presented the client with a full waterproofing specification and CAD detail drawings.

The repair work involved the complete stripping of the roof, including existing BUFR waterproofing and insulation. A self adhesive vapour control layer was installed to avoid the risk of hot bitumen falling through the metal deck 20 and then a PU adhesive was used to install the insulation as well as a self adhesive underlay. Other products used were SA Superbar Vapour Barrier, Enertherm Insulation and SA Superbase FireBLOC Underlay.

The school had a history of vandalism, so to reduce the risk of arson, Ultra prevENT mineral capsheet was specified. Ultra prevENT features graphite firewall technology to stop the spread of fire from external sources.
